## Tank Insulation/ Tank Corrosion Lining

## DELANO GROWERS

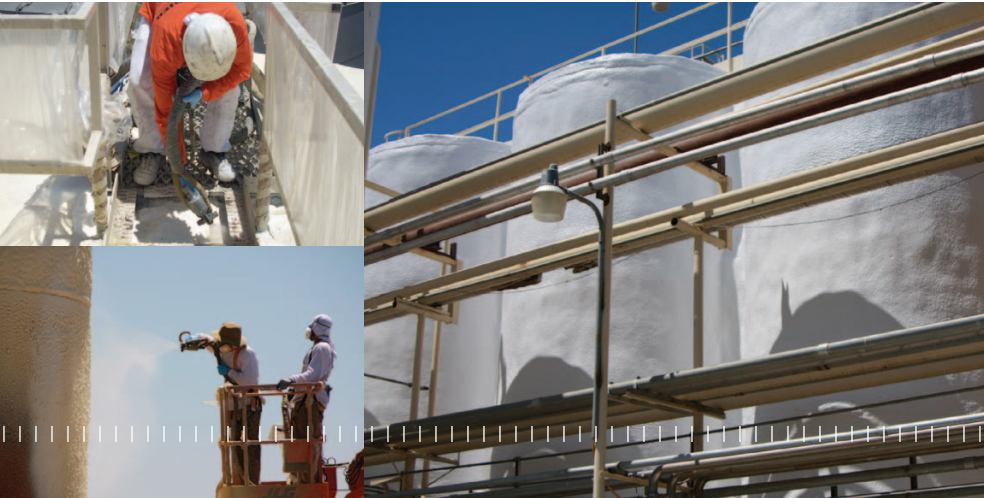
This modern agricultural business offers diverse challenges: in addition to having 20 existing wine and juice tanks that needed exterior insulation and resurfacing on the exterior & interior, the firm operates its own waste water treatment plant. The treatment tanks must maintain a constant temperature of 105°F in order for aerobic bacteria to process the waste into potable water.

- Applied 4” of polyfoam, Nitrocoat base coat, and urethane top coat to wine and juice tank exteriors
- Sandblasted and applied 80 mils PermaDri liquid membrane to tank interiors

Barrier rehabbed the interior of the wine and juice tanks and applied polyurethane foam insulation to the company’s wine, juice and its waste water tanks, ensuring that both types of tanks would be able to maintain the proper temperatures required for safe, efficient operation.
